SYMPTOMS DAMAGE TO THE HYDRAULIC REGULATOR PROPELLER LUN-7816

Abstract

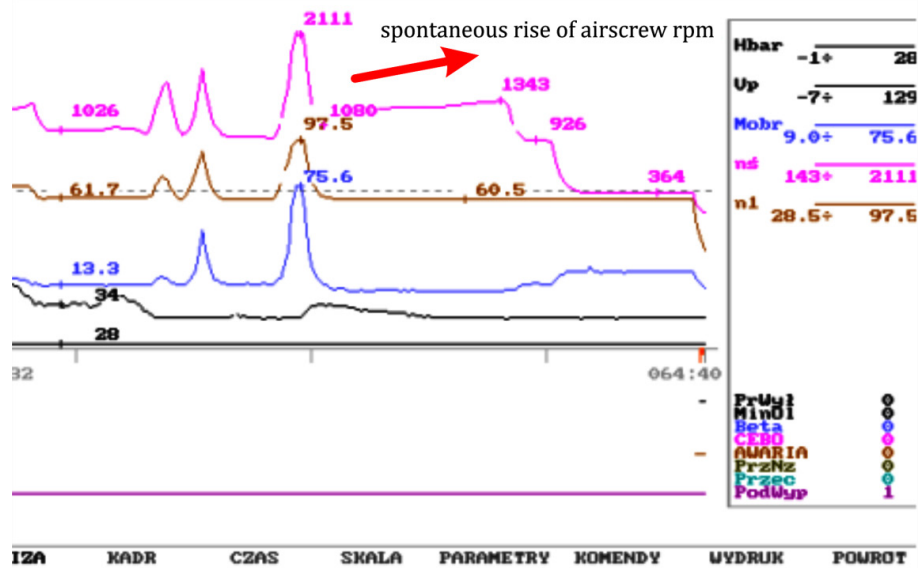
A detailed analysis of information recorded by the on-board flight analyser indicated some possibilities of initial identification of symptoms that precede a failure of the LUN-7816 airscrew drive. These symptoms include variations of airscrew rpm. Fig. 4 shows an inexplicable, spontaneous rise of airscrew rpm n_s during a ground test of the PZL-130TC1 'Orlik' aircraft #034, which broke down during its second flight after the recorded event.

It was thus possible to identify deficiency symptoms of the LUN 7816 airscrew drive even two flights before its eventual failure.

Fig. 4. The waveform with a spontaneous rise of the airscrew rpm n_s recorded during a ground test of the PZL-130TC1 'Orlik' aircraft #034

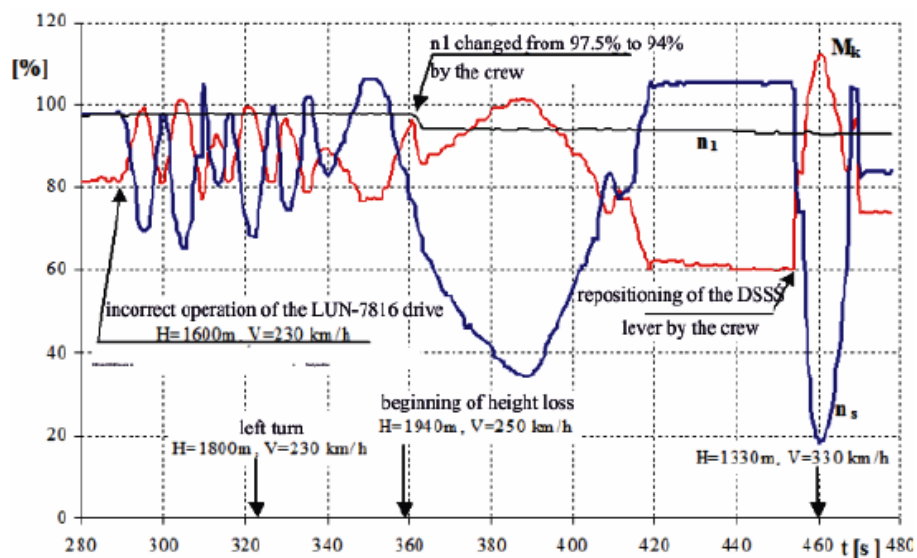
Another event that also illustrates the preliminary phase of the drive deficiency happened during a flight of the aircraft #022 – Fig. 5. The aircraft drive was then disassembled in witness of a commission at the premises of the drive manufacturer and the examination demonstrated a crack of a roll in the HK1015 bearing.

Fig. 5. Changes of airscrew rpm during a flight of the aircraft #022

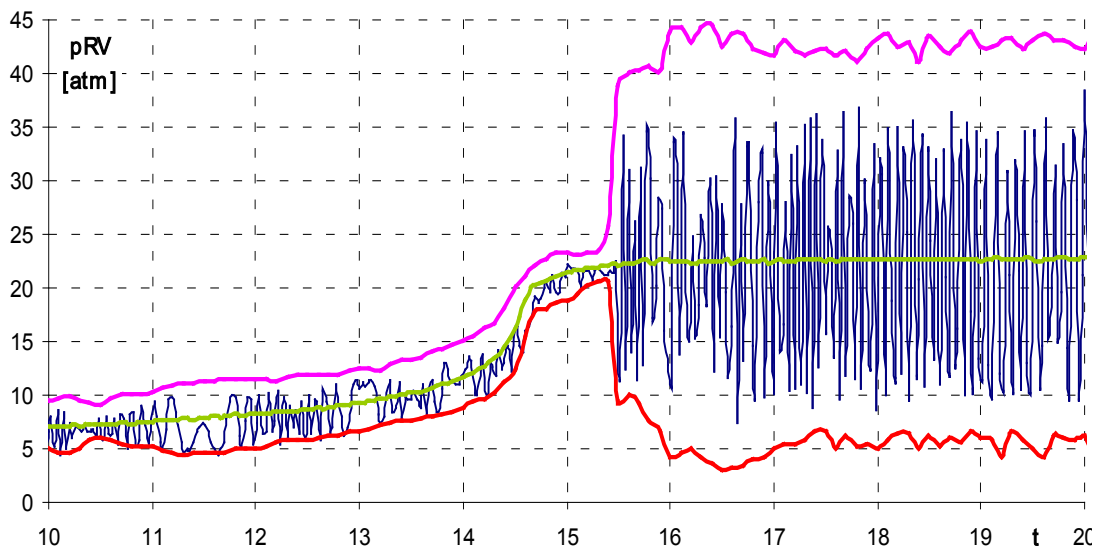
The comparative analysis between information gathered during ground tests of the motor and recorded by the ADC boards (PCBs) with consideration to Nyquist conditions and the ones downloaded from the S2-3ap recorder made it possible to find out the correction factor for the characteristic frequencies of amplitude pulsations. For instance, for a pulsation frequency of about 500 Hz the correction factor is 1.45.

Figure 6 depicts discrepancies of peak values obtained for signals from the on-board monitoring recorder (sampling frequency of 34 Hz/channel) and the ADC measurement board.

Fig. 6. The effect of the sampling frequency for the signal of the p_{RV} pressure onto values of pulsations measured during tests

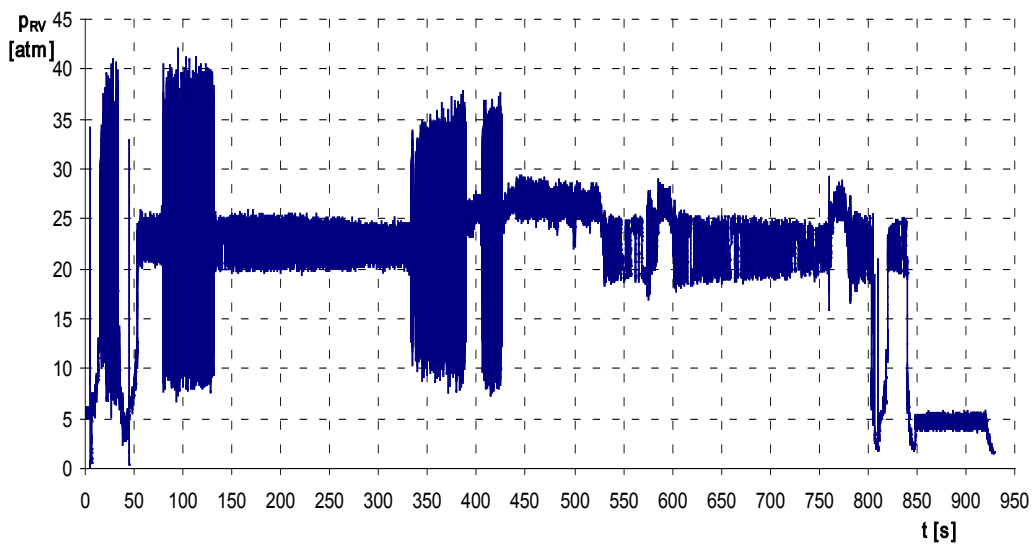
Fig. 9. Variation of oil pressure measured across the outlet from the gear pump of the LUN 7816 airscrew drive, during a ground test of the aircraft #012 with engine # 994002

The analysis of characteristic curves of oil pressure vs. engine rpm made it possible to find out that excessive pulsations occur mostly downstream the gear pump of the airscrew drive (the p_{RV} pressure) and predominantly for ranges from the idle run to about 80% and the turbine generator rpm (n_g).

With consideration to the characteristic frequency (about 500 Hz) and to the pulsation amplitude (about 20 atm.) it was found out the observed phenomenon is hazardous to the HK1015 bearing of the airscrew drive. In addition, 0 depicts also the dynamic properties of the phenomenon mapped onto the data downloaded from the flight recorder.

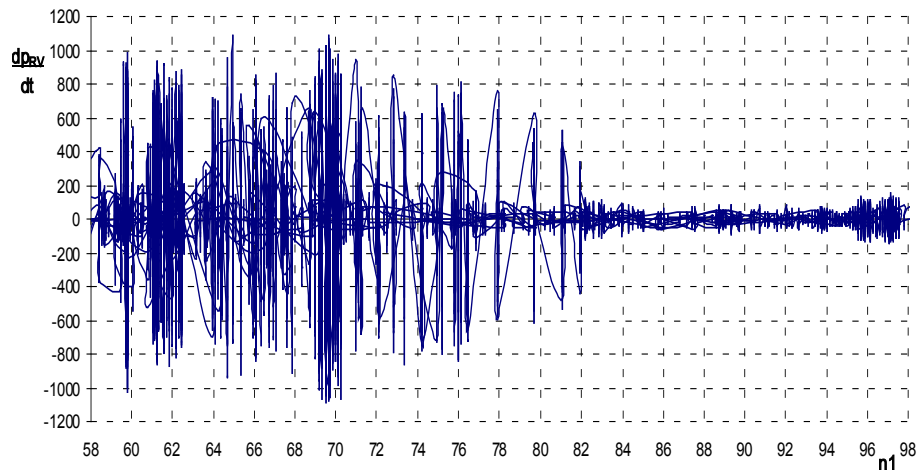
Fig. 10. Dynamic variations of the differential oil pressure (p_{RV}) downstream the pump for the LUN 7816 airscrew drive as the function of the turbine generator rpm (n_g)

The test results that were obtained at that stage of studies made it possible to reveal that considerable pulsations of the p_{RV} pressure occurred predominantly during ground tests of the driving unit.

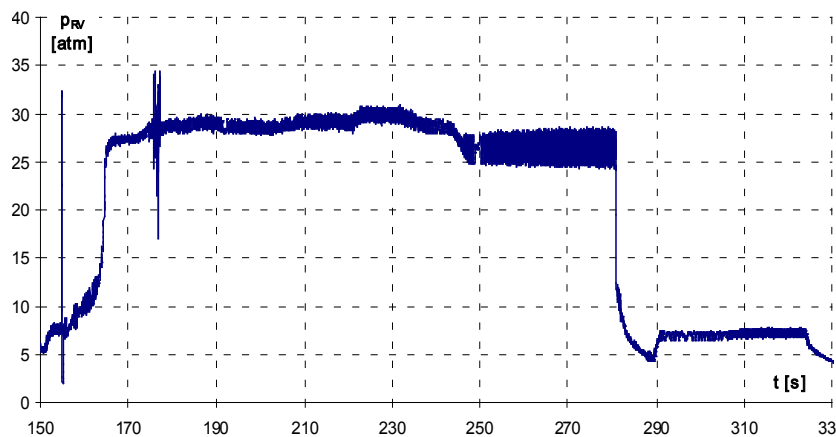
The foregoing observation gave an incentive to carry out an experiment with the aim to find out whether or not the airfield surface affects the measurable oil pressure jumps. The aircraft engine was started up twice for short times of operation, once on a concrete pavement, the second time on grass – Fig. 11 and Fig. 12. The measurement results revealed some slight differences of oil pressure pulsations (recorded when the DSSŚ lever was repositioned and during the 1st phase of warming up), which makes it impossible to reject the hypothesis about the effect of the airfield surface onto provoking oil pressure pulsation.

Fig. 11. Test on concrete pavement – a pressure jump is visible during movement of the DSSŚ lever from the ‘flag’ position to the position of ‘released’ (switchover of oil flow from the channel of a large angle to the low angle channel). Oil pressure pulsation recorded for the n_g range was about 70%

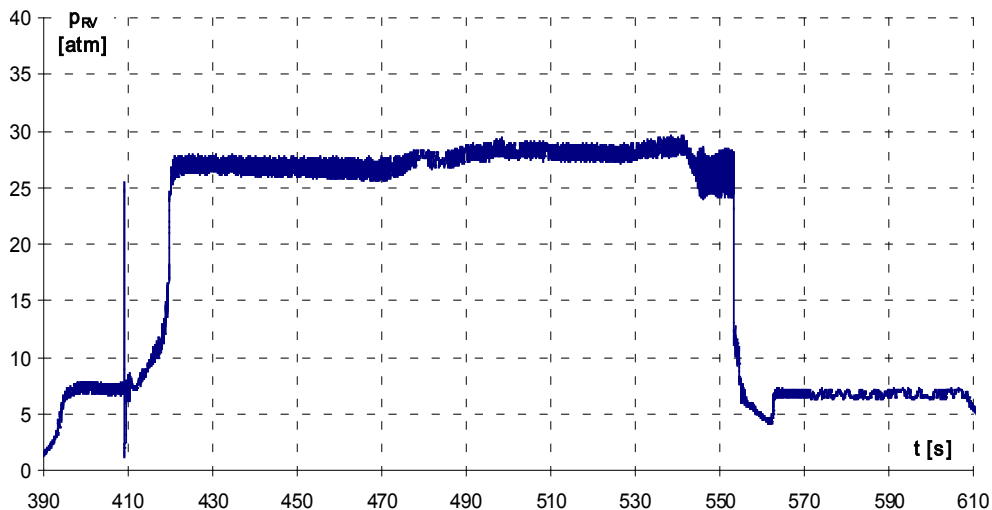
Fig. 12. Test on grass – no pulsation is visible and the pressure jump associated with moving the DSSŚ lever from the ‘flag’ position to the position of ‘released’ is much less
