## THE PROCESS OF REGENERATIVE HEAT TREATMENT OF THE VALVE CHAMBER OF THE STEAM TURBINE

Agata Wieczorska

### **Abstract**

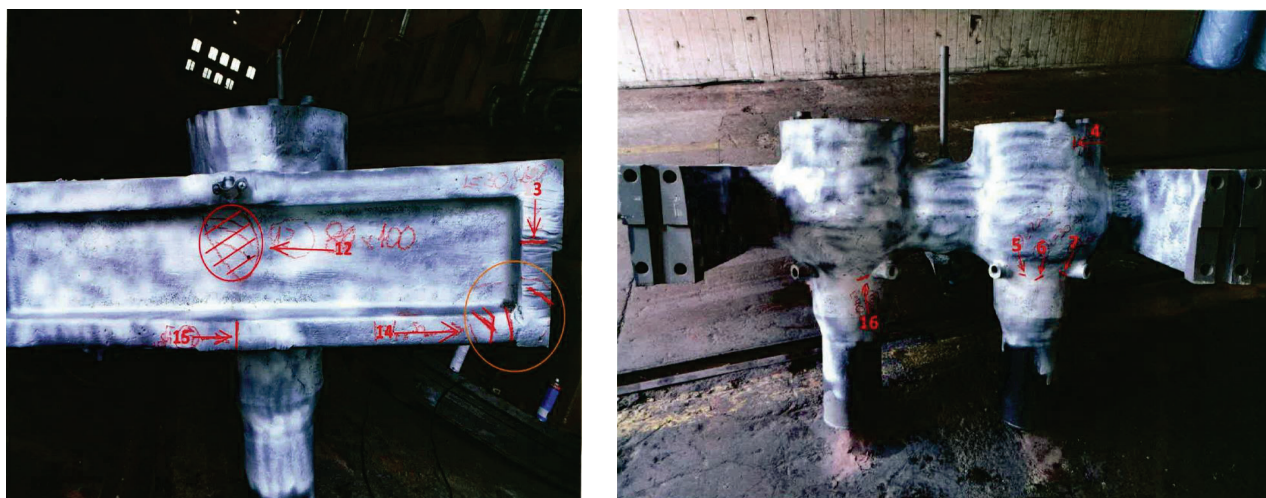
The 16 cracks were detected on the outer surface of the chamber, whereas 3 cracks on the inner surface. All the cracks detected were qualified for removal by milling, the rebate locations were re-examined by the magnetic-powder method to verify the correctness of this operation, because all defects had to be removed to healthy material. The resulting milling results were qualified for repair by welding, which will be carried out only later in the revitalization process. An example of detected discontinuities is shown in Fig. 1 [3].

Fig. 1. Detected material discontinuities, magnetic-powder testing

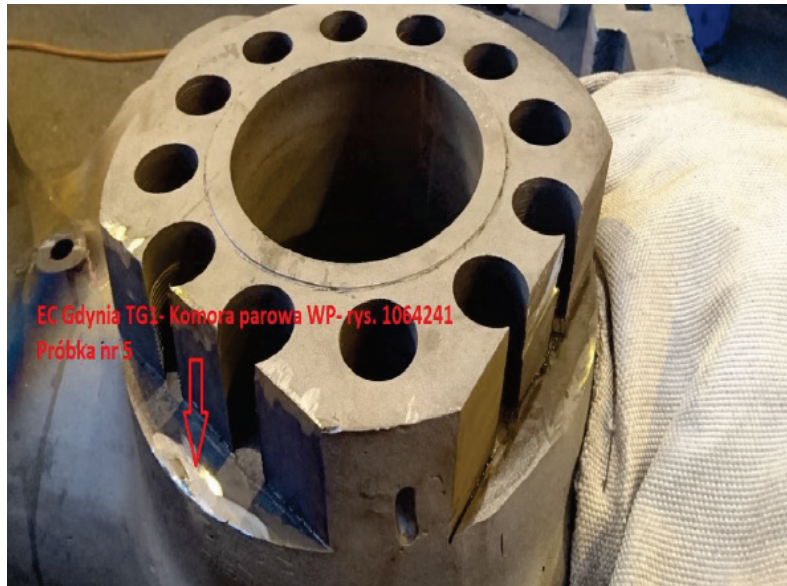
Fig. 2. Place of sample cut-out No. 5 – before revitalization

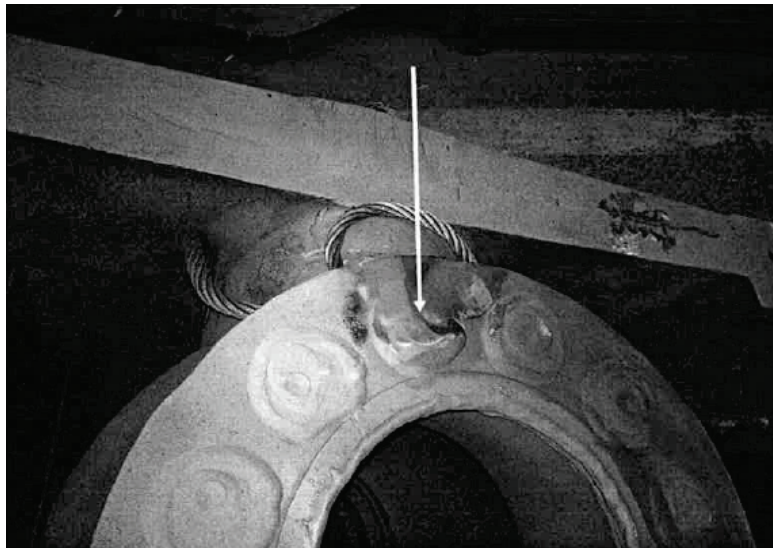
Due to the inability to take a sample for impact and microstructural tests of the weld cross-section, due to further suitability of the valve chamber for exploitation, only hardness tests were performed on the customer-selected weld marking the overall condition of the welds throughout the chamber. The results obtained are presented in Tab. 6 and place of measurement of weld hardness shown in Fig. 3.

Hardness HV5		
Material	HAZ	weld
196-204	216-236	196-205

Fig. 3. Place of measurement of weld hardness
