## ANALYSIS OF POSSIBILITY OF REPAIRING WELDING OF SELECTED OF THE STEAM TURBINES

### **Abstract**

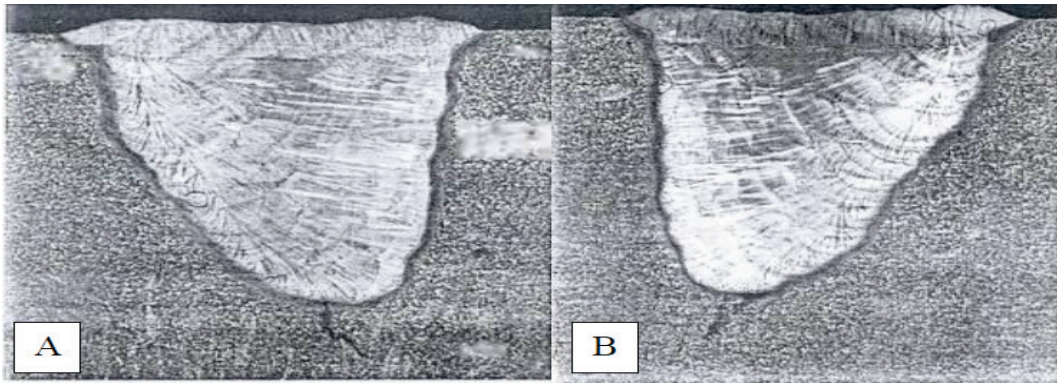
1. No indications exceeding the registration level were detected in the weld, while in the native material discontinuities of 150 mm length were detected, penetrating to a depth of about 8 mm along the ridge under the weld.
2. In the central zone of the weld on the length of 120 mm there are 11 flat transverse indications (ERG  $\approx$  Ø3-6 mm), in the home material 5 scattered spot discontinuities under the weld were detected (ERG  $\approx$  Ø1.8-2.0 mm).
3. Two point discontinuities were detected in the weld – ERG  $\approx$  Ø1.7 mm and ERG  $\approx$  Ø1.3 mm in layers at 32 and 42 mm depth from the face, while in the native material 3 ERG  $\approx$  Ø1.2-1.7 mm in the band were found away from the bottom of the weld 7-13 mm.

*Fig. 1. Macrostructure of weld No. 1 – cross-section A and B*

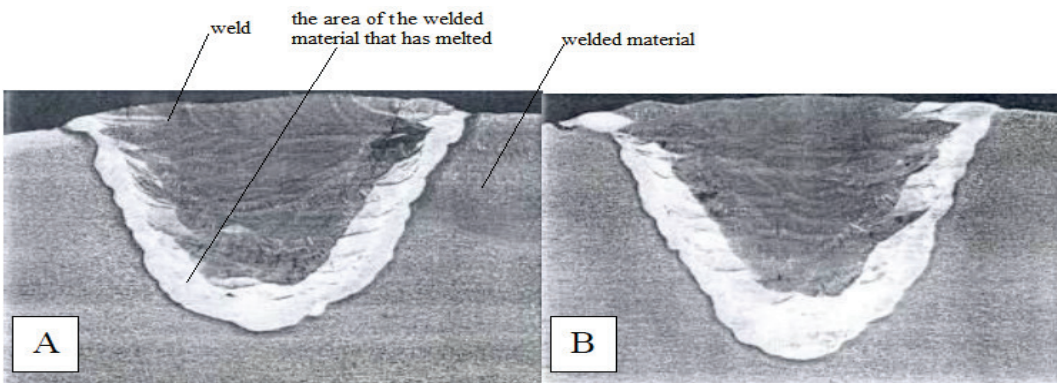
*Fig. 2. Macrostructure of weld No. 2 – cross-section A and B*

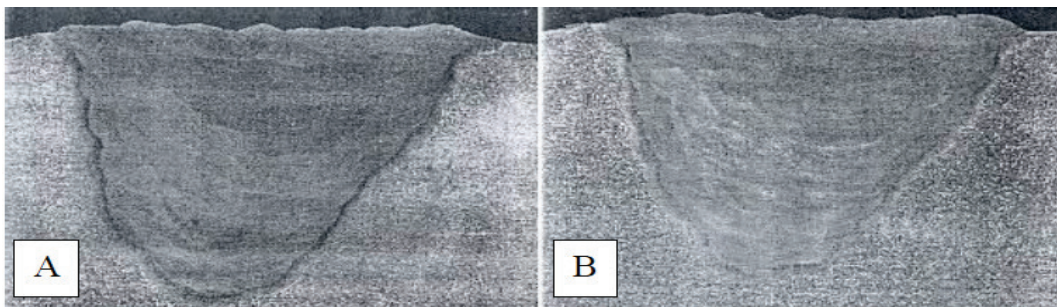
*Fig. 3. Macrostructure of weld No. 3 – cross-section A and B*

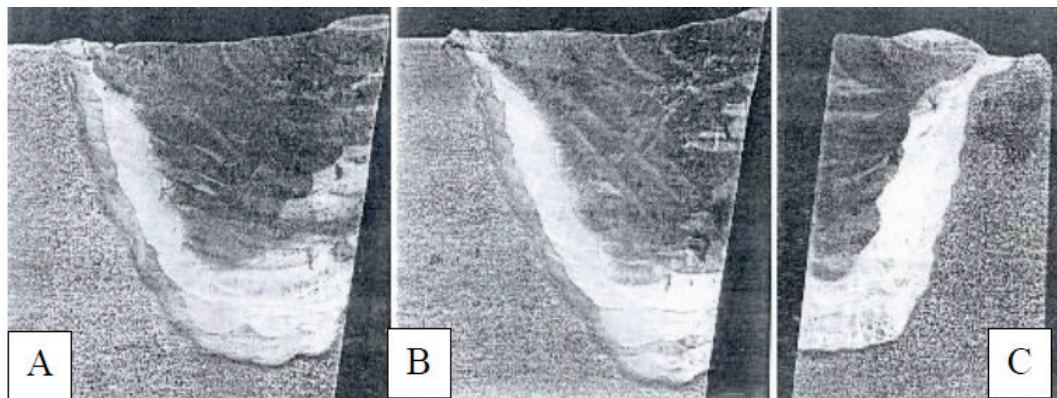
*Fig. 4. Macrostructure of weld No. 4 – cross-section A, B and C*

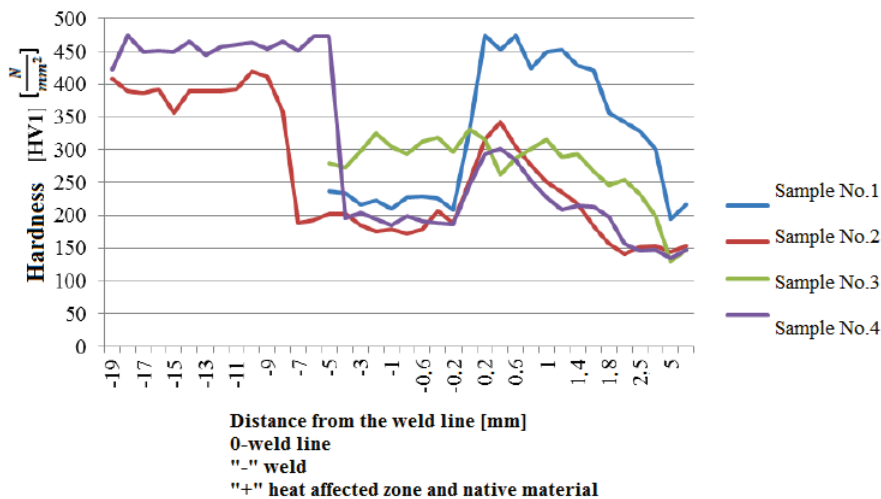
Fig. 5. Diagram of hardness dependency [HV1] from the distance from the weld line [mm] on the face of welds

The hardening of the heat-affected zone of all tested welds is a consequence of the martensitic transformation. In all welds, the hardening of the heat-affected zone is highest at the root. The most hardened (> 450HV) is the heat affected zone around the entire circumference of the No. 1 weld. In welds No. 2, 3 and 4, the hardening of the heat affected zone at 400-450 HV occurs only at the root of weld. There are cold cracks in the entire cross section of the No.2 weld. The cracking intensity is the highest in the central zone of the weld length. The cracking of the heat and parent material zone occurs under the No. 1 weld. A band of material adjacent to the root is fractured by ca. 85% of the length of the weld. Cracks are initiated on the inside-grain surface of the splitting, which results from the post-exploitation fragility of the material, [1, 4, 6, 7].

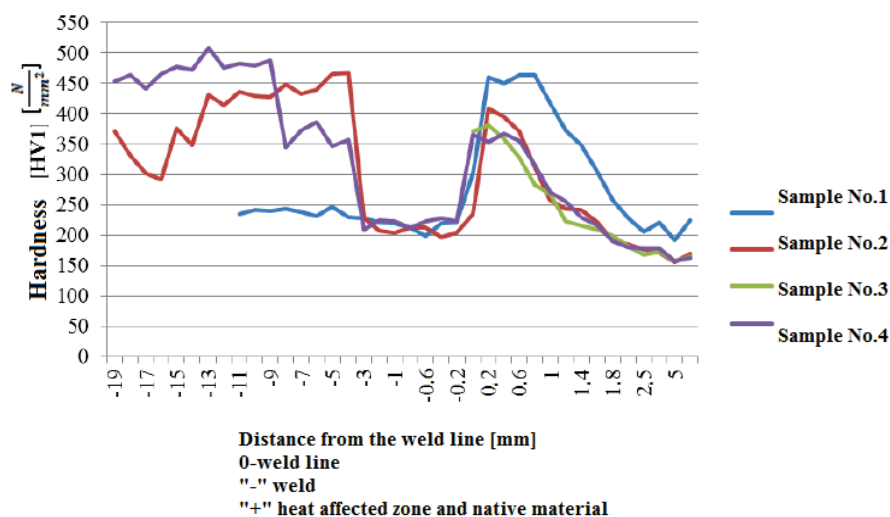
Fig. 6. Diagram of hardness dependency [HV1] from the distance from the weld line [mm] to 1/2 of the weld height

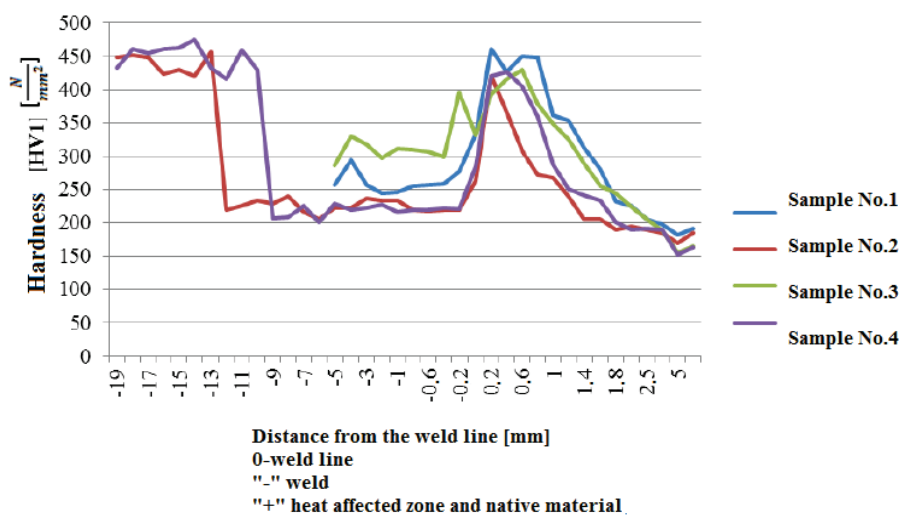
Fig. 7. Diagram of the hardness dependency [HV1] from the distance from the weld line [mm] in the ridge of the welds

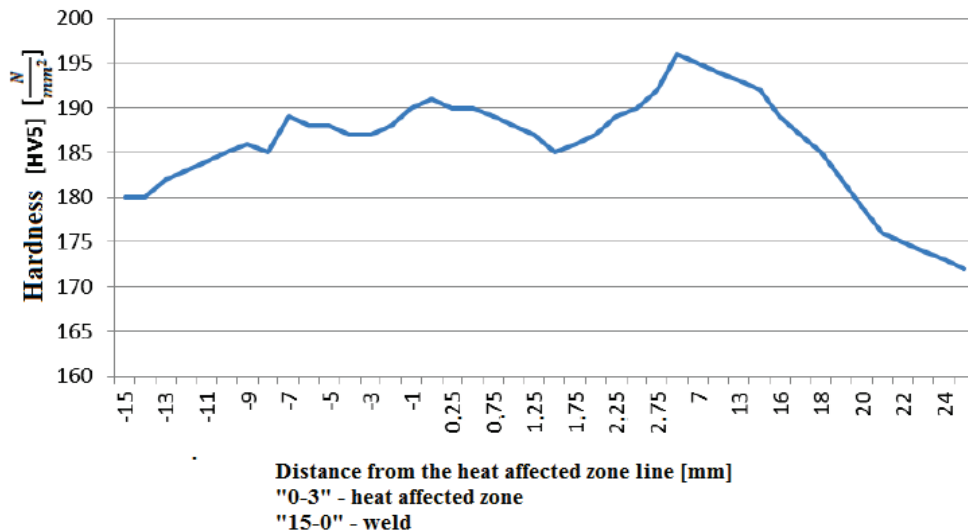
Fig. 8. Diagram of the hardness dependency [HV5] from the distance from the fusion line [mm] on the weld surface

Considering samples from L17HMF material, it can be concluded that the obtained hardness is very diverse, in particular, the hardness of the weld, which reaches even 450HV1, and the hardness of the native material oscillates within 190HV1. In the case of welding of L21HMF material, we obtain hardness within the tolerances between the weld, the heat affected zone and the native material.
