COMPUTER AIDED VISUAL INSPECTION OF THE TECHNICAL CONDITION OF GAS TURBINE BLADES DURING THEIR OPERATION PERIOD

Józef Blachnio, Artur Kulaszka

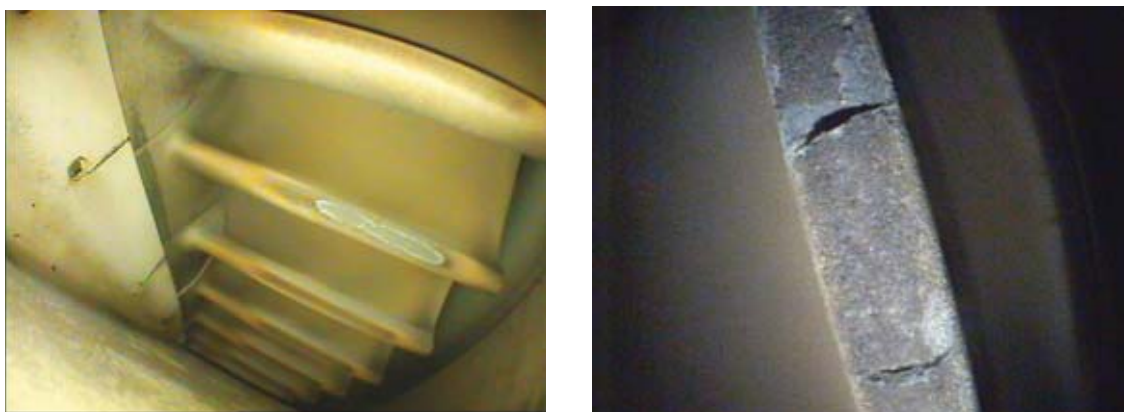
Fig. 1. Examples of damages to the edge of attack of turbine blades due to temperature [3]

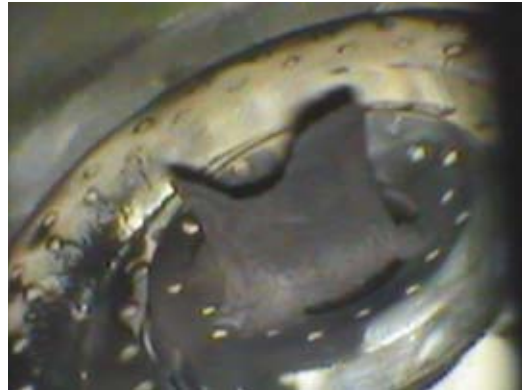
Fig. 2. Carbon deposit on a fuel injector of a turbojet engine [3]

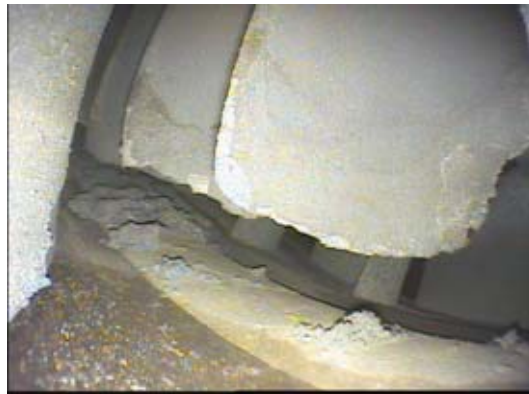
Fig. 3. Damage to turbine blades due to temperature[3]

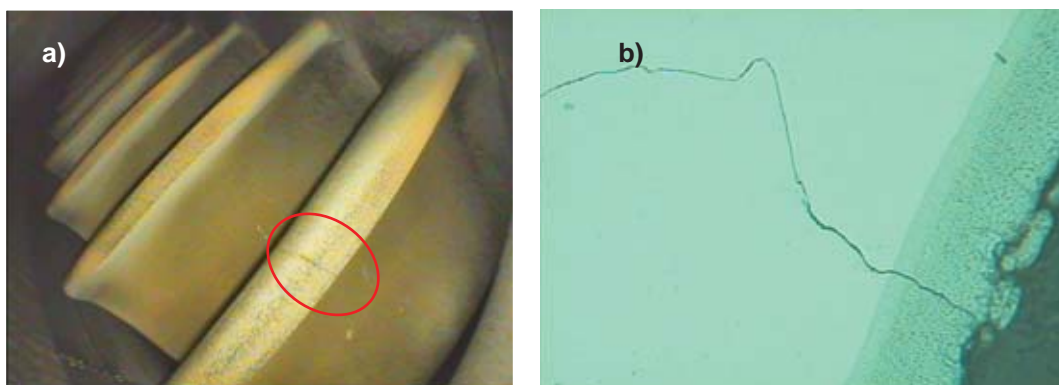
Fig. 4. Image of a break of a protective coating propagating into the blade native material [3]: a) videoscope image; b) image from a 450x magnification microscope

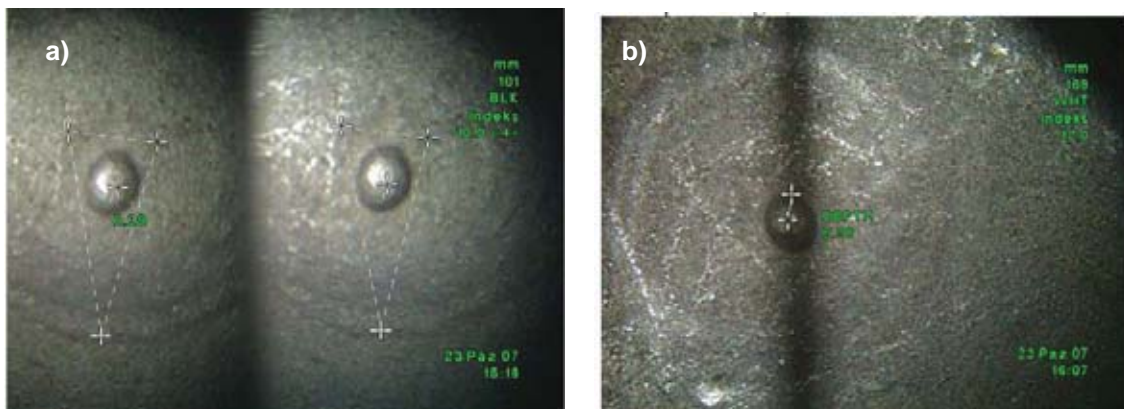
Fig. 5. Measuring the convexity radius by the [4] a) „Stereo”; b) „Shadow” method

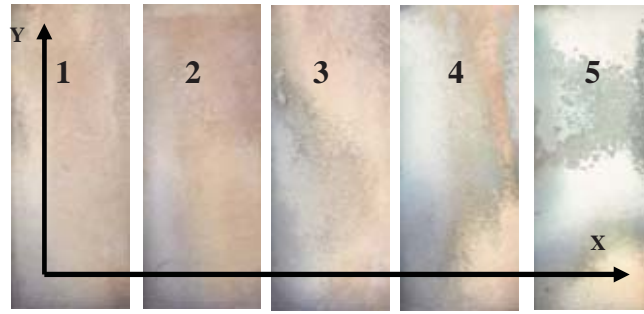
Fig. 6. Images of a gas turbine blade surface coated with the ŻS-6K alloy, arranged in an order of the increasing material overheating

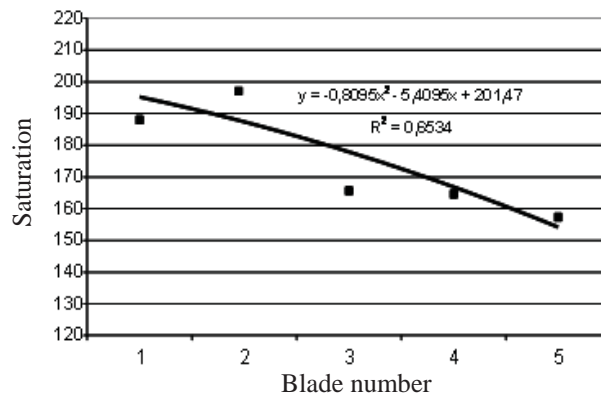
Fig. 7. Examples of a changing position of the maximum amplitude of the image saturation for different conditions of a blade [4]

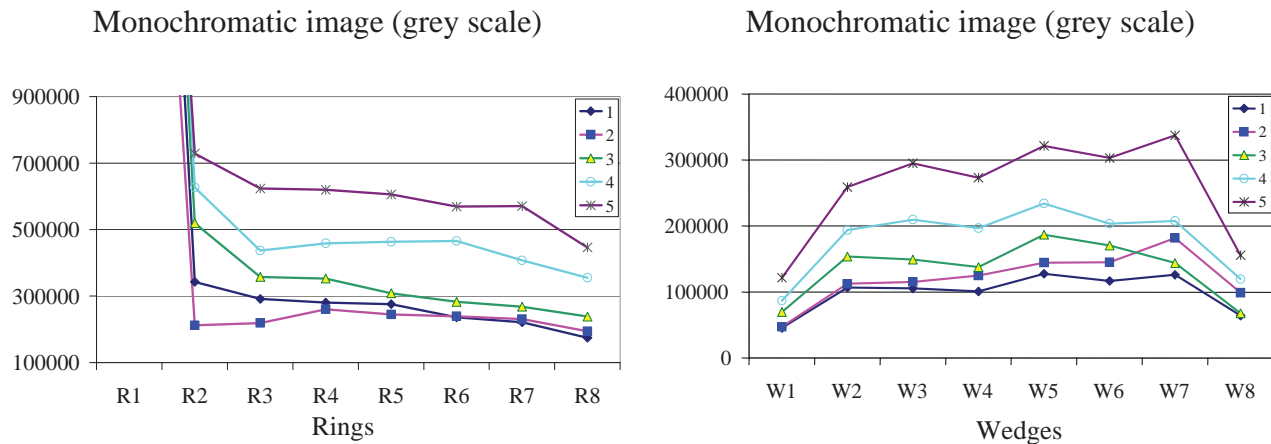
Fig. 8. Values of rings and wedges in grey shades for different blade technical conditions [5]

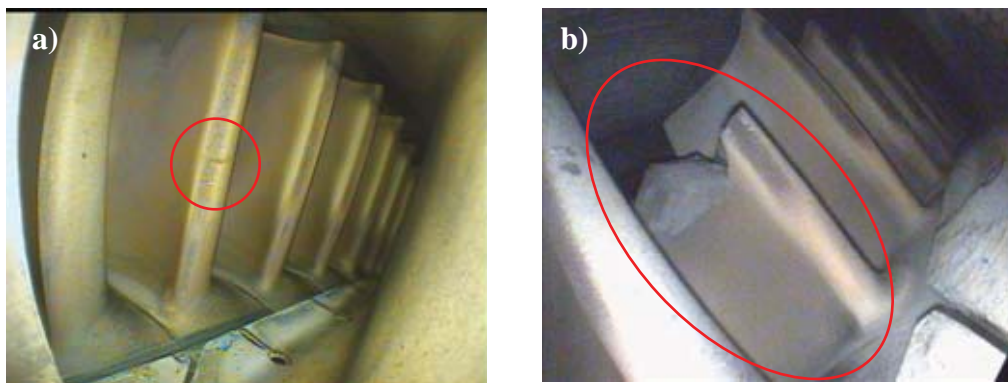
Fig. 9. Blades of a RD-33 high pressure engine turbine rotor : a) with an indication which can point to a crack in the blade; b) a broken off blade
