## BEHAVIOUR OF THE EXHAUST VALVE CLADDING FACE UNDER THE SERVICE CONDITIONS

### **Abstract**

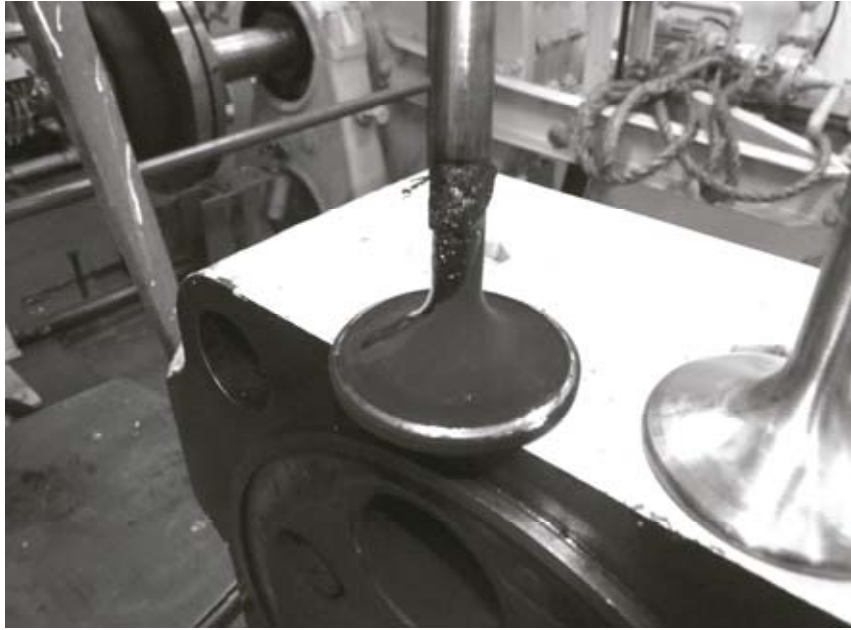
*Fig. 3. The valve heads: after service (on left) and new one (on right)*

In this part of the investigation the valve with a clad layer on the face was examined by real working conditions using the laboratory two-stroke diesel engine L22 for two years. The engine was fuelling with both ordinary light fuel and biodiesel fuel. After removing from the valve head from the cylinder head the face surface were fully inspected optically. There were no damages and the surface was shining in the great deal however some dark “spots” on it. On the Fig. 3 was presented valve head after removing and a new one and on the Fig. 4 typical picture of the face surface after service was presented. After cleaning and cutting off the steam the rest of the head were cut into the samples and prepared to the more detailing investigations. The first step was observation of the surface of the face with the special attention to the mentioned dark “spots”. To this task SEM microscope was used and the results were presented on the Figures 5 and 6.
