EVALUATION OF DIAGNOSTIC INFORMATION ABOUT MARINE ENGINE WORK BASED ON MESUREMENT OF THE ANGULAR SPEED DISCRETE VALUE

Mirosław Dereszewski, Adam Charchalis, Stanislaw Polanowski

Gdynia Maritime University, Mechanical Faculty
Morska Street 83, 81-225 Gdynia, Poland
tel.: +48 58 6901398, +48 58 6901347, +48 58 6901480
e-mail: deresz1@02.pl, achar@am.gdynia.pl, stpolanowski@gmail.com

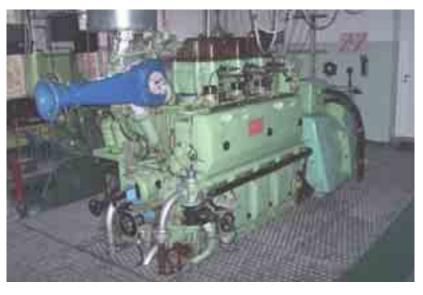
Fig. 1. General view of the Sulzer 3 AL 25/30

The main engine particulars are reported in Tab. 1. It is turbocharged medium speed diesel engine designed by Sulzer. This 3- cylinder in row engine develops 408 kW, at rotational speed of 750 rpm. The engine drives alternate current electro generator GD8-500-50, 500kVA, connected to the main electric board. The load of the engine can be fluently adjusted by changing of the load of generator (adjustable resistor). The high-pressure fuel system has three injection pumps, one for each cylinder. General view of the engine is presented in Fig. 1.

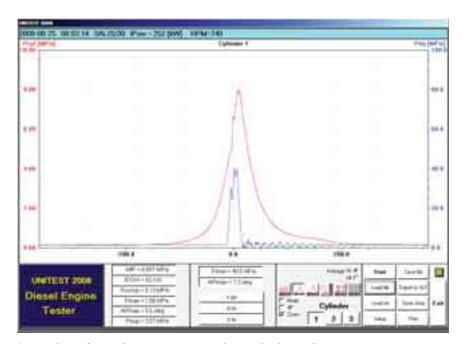
Fig. 2. Window of Diesel Engine Tester with in-cylinder and injector pipe pressure picture

The crankshaft angular speed variations were measured at the crankshaft free end. Measurements were carried out at different loads, i.e. 150, 200, 250 kW and idle run. IAS measurement was conducted under different loads, in healthy condition, with implemented malfunction of small and significant leakage of injection pump and partly plugged injector. The level of fuel leakage was set up observing the picture of decreasing of high-pressure value at UNITEST 2008 screen (Fig. 2).

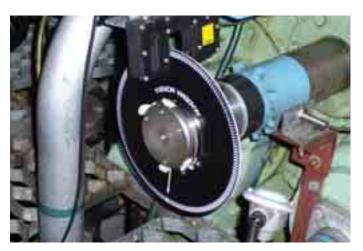
Fig. 4. Measurement disc and laser sensor mounted at crankshaft free end

The crankshaft angular speed variation signal transmitter is the perforated disc with 180 proportional slots and 180 teeth, at the disc's circumference. Number of impulses going through the slot or "blind" due to tooth depends on instantaneous angular speed. The picture of the disc and the sensor is presented in Fig. 4.

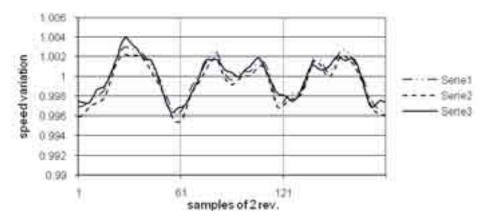
Fig. 5 Waveforms of angular speed variation of 3 runs, healthy engine, load 250 kW

ambient conditions have an impact at combustion process, then is necessary to determine the level of deviations between angular speed waveforms shape recorded during separate starts of the engine with time intervals. Figures below present comparison of 3-separate, independent records of IAS waveforms of healthy engine working at load 250 kW. The angular speed is presented as "instant-to-mean" ratio. Very important factor for further detecting and identification of malfunctions is the shape and the magnitude of difference value of compared runs' waveforms. Fig. 6 presents comparison of two template runs of healthy engines at load of 250 kW. The maximum observed deviation is $\pm 0.1\%$ of angular speed mean value.

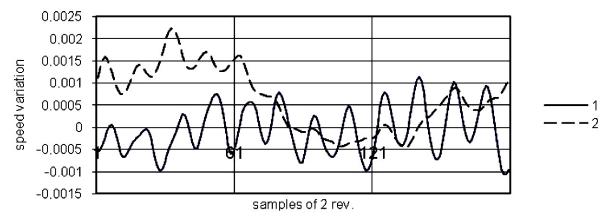
Fig. 8. Angular speed variations of healthy engine (1) and fuel leakage (2), load 150 kW

First malfunction was the leakage from injection pump number 2. The level of leakage was adjusted basing on observation of high-pressure fuel decreasing, at UNITEST display, and was established at 30% max. pressure down.

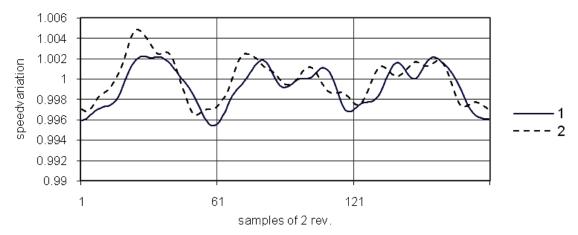
Fig. 9. Comparison of healthy engine (1) and partly plugged injector's nozzle (2), load 250 kW

In order to get records of impact of an injector malfunction, specially prepared injector with plugged 30% of nozzle openings was installed in 2nd cylinder's head. The engine was working at different loads. Simultaneously with angular speed recording, in-cylinder pressure and injection pressure were measured. The waveform of disturbed combustion in comparison with healthy one is presented in Fig. 9.

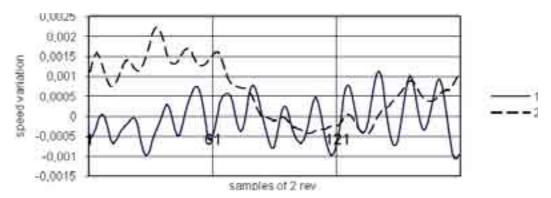
Fig. 10. Angular speed variation difference comparison: two runs healthy engine (1;) healthy and fault of fuel leaking (2), domain of samples of 2rev.,250 kW

After analysis of healthy and disturbed waveforms of IAS, became obvious that simple comparison is not sufficient for definition of the malfunction. Better picture of disturbances is given by comparison of waveforms presenting angular speed difference between healthy and faulty condition, at the same load value [6]. Analysis of tendencies and magnitudes can give the information about malfunction presence and its character. Samples of measured angular speed differences between: two healthy, healthy - leakage fault and healthy - plugged injector are presented at Fig. 10. and Fig. 11.

Occurring of the malfunction is shown due to magnitude amplification. Detection of faulty cylinder in the case of fuel leaking can be done in the way of span analysing between maximum and minimum value of variation's difference, in every interval (240°) between TDC's of the work stroke of each cylinder (Fig. 10). In the case of partly plugged injector, simple analysis of amplitude span is insufficient (Fig. 11).

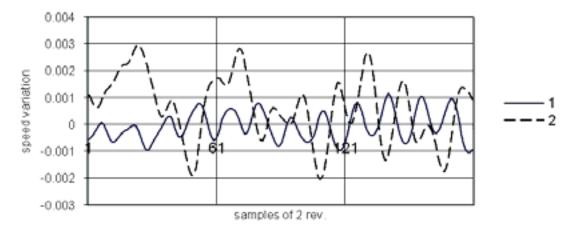
Fig. 11. Angular speed variation difference comparison: two runs healthy engine (1) healthy and fault of plugged injector (2), domain of samples of 2rev. 250 kW
