## EXAMINATION OF THE DYNAMIC PROPERTIES OF 1<sup>ST</sup> STAGE ROTOR BLADES IN ONE-PASS ENGINE COMPRESSORS UNDER OPERATING CONDITIONS

*This article includes studies of vibration and stress amplitudes in the 1<sup>st</sup> stage rotor blades of jet trainer one-pass engine compressors before and after refurbishment in operating conditions.*

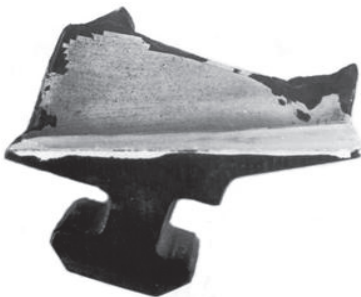
Fig. 1. Hammer root of 1st stage rotor blade in one-pass engine compressor before refurbishment

This article includes studies of vibration and stress amplitudes in the 1<sup>st</sup> stage rotor blades of jet trainer one-pass engine compressors before and after refurbishment in operating conditions. Before the refurbishment the 1<sup>st</sup> stage compressor blades were attached to the rim using the hammer root design (Fig. 10), whereas after the refurbishment the dovetail design was applied (Fig. 20).

The difference between the vibration amplitudes of 1<sup>st</sup> stage rotor blades in one-pass engine compressors before and after the refurbishment results from the difference in how the blades were attached to the disc. Before modernisation the hammer-type root was used (Fig. 1), whereas after refurbishment dovetail-type fittings were applied (Fig. 2).

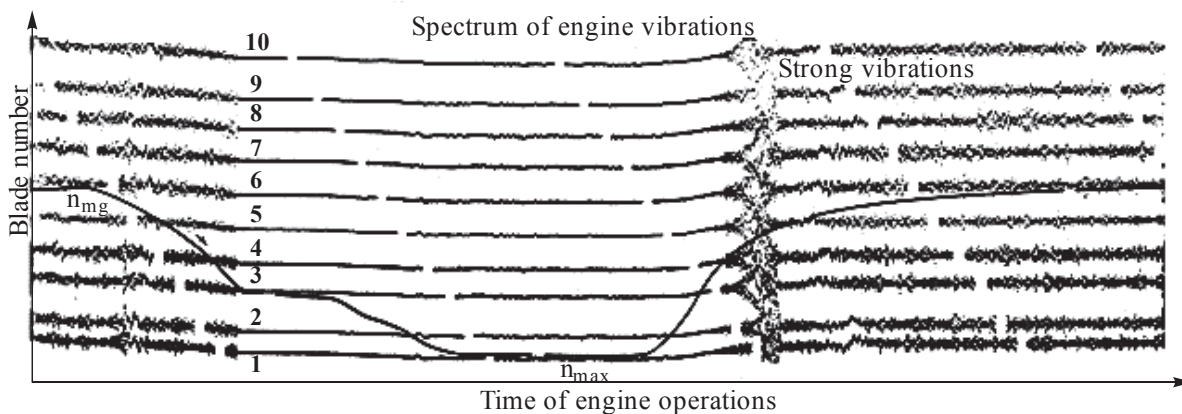
Fig. 3. Vibration spectrum of 1st stage rotor blades in one-pass engine compressor before refurbishment

Tests were carried on several decommissioned engines. Fig. 30 presents vibration amplitudes for 10 rotor blades with rotation speed fluctuating from  $n_{mg}$  to  $n_{max}$  and then back down to  $n_{mg}$ . The rotating stalls occurred in 6,500 to 10,300 rpm range. Very stress amplitudes were recorded when rotation speed was reduced from  $n_{max}$  to  $n_{mg}$ . They were estimated to be ca. 350-400 MPa (1 mm of doubled amplitude corresponds to a stress' amplitude of 61 MPa). Such a level of vibration could lead to crack initiation, especially when we bear in mind that it is possible for it to be sustained when the DSS is very gradually reduced from  $n_{max}$  to  $n_{mg}$  (Fig. 40). In such situations there are differences between individual blade vibration amplitudes arising from slightly different rotation speeds. The behaviour of such individual blade vibrations suggests flutter.

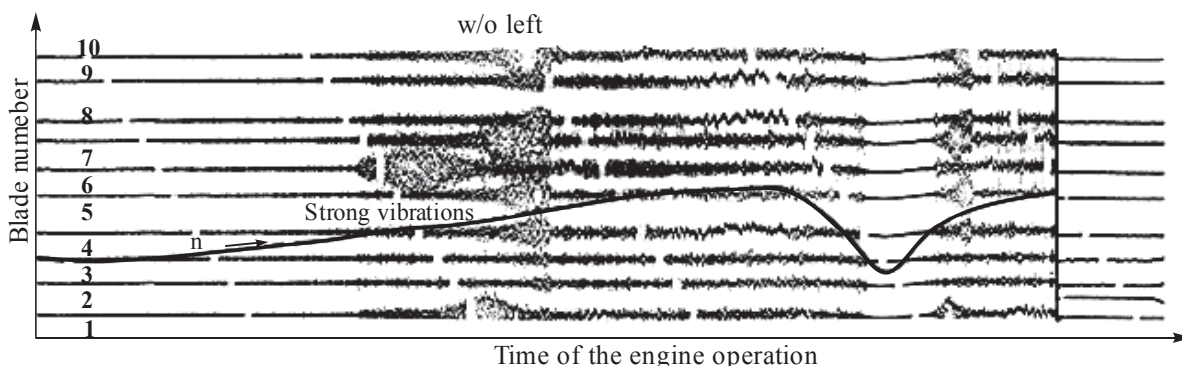
Fig. 4. Vibration spectrum of 1st stage rotor blades in one-pass engine compressor before refurbishment, without felt

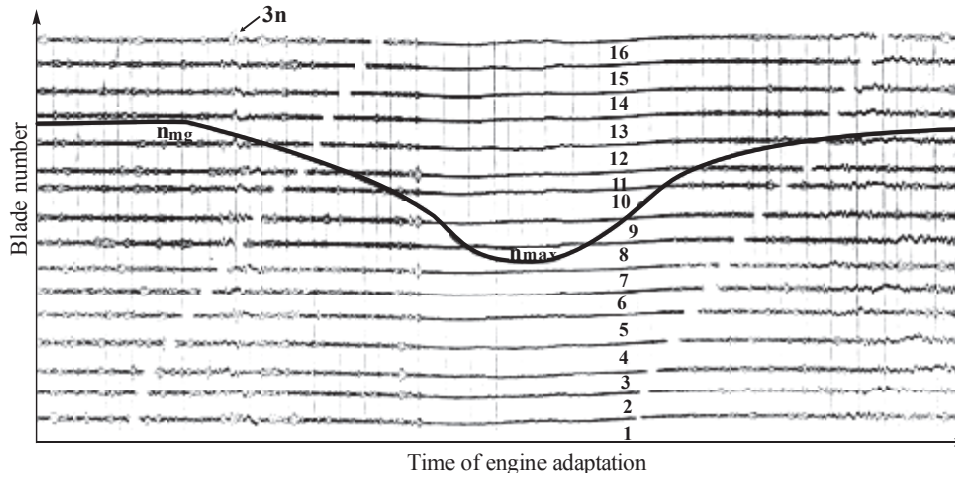
Fig. 5. Vibration spectrum of one-pass engine rotor blades after refurbishment (no. 1)

Example oscillograms from the vibration tests of the 16 blades are shown in Fig. 5-7. These show the vibrations of three randomly selected one-pass engines after refurbishment (marked 1, 2 and 3) out of a total of 50 engines. The engine vibration spectra cover the full rotation speed range.

Fig. 50 shows forced blade vibrations excited by the third engine order ( $3EO = 3n$ ) during acceleration from  $n_{mg}$ . This does not occur simultaneously in all the blades, which indicates free vibration frequency differences in the blades on the rim. Fig. 60 shows blade vibration forced by the 2<sup>nd</sup> EO ( $2n$ ) at a rotation speed close to  $n_{max}$ , where the vibrations of disc and blades appear during acceleration. In Fig. 70 disc and blade vibrations appear during reduction of rotation speed to  $n_{max}$ , and vibrations forced by the second and third excitation frequencies are also visible.

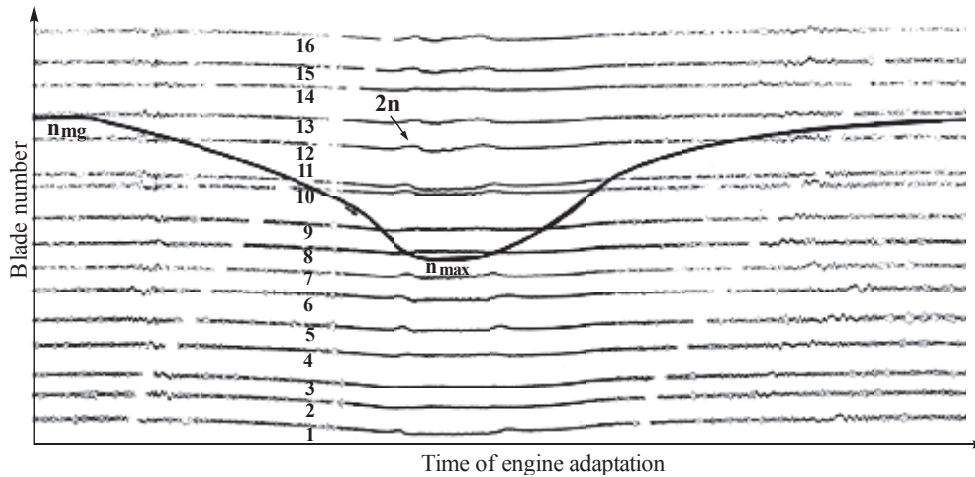
Fig. 6. Vibration spectrum of one-pass engine rotor blades after refurbishment (no. 2)

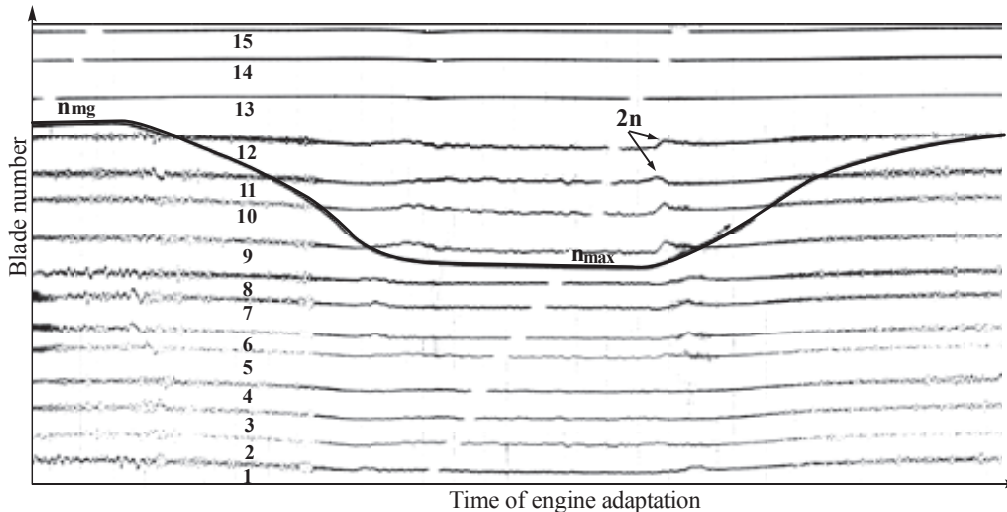
Fig. 7. Vibration spectrum of one-pass engine rotor blades after refurbishment (no. 3)

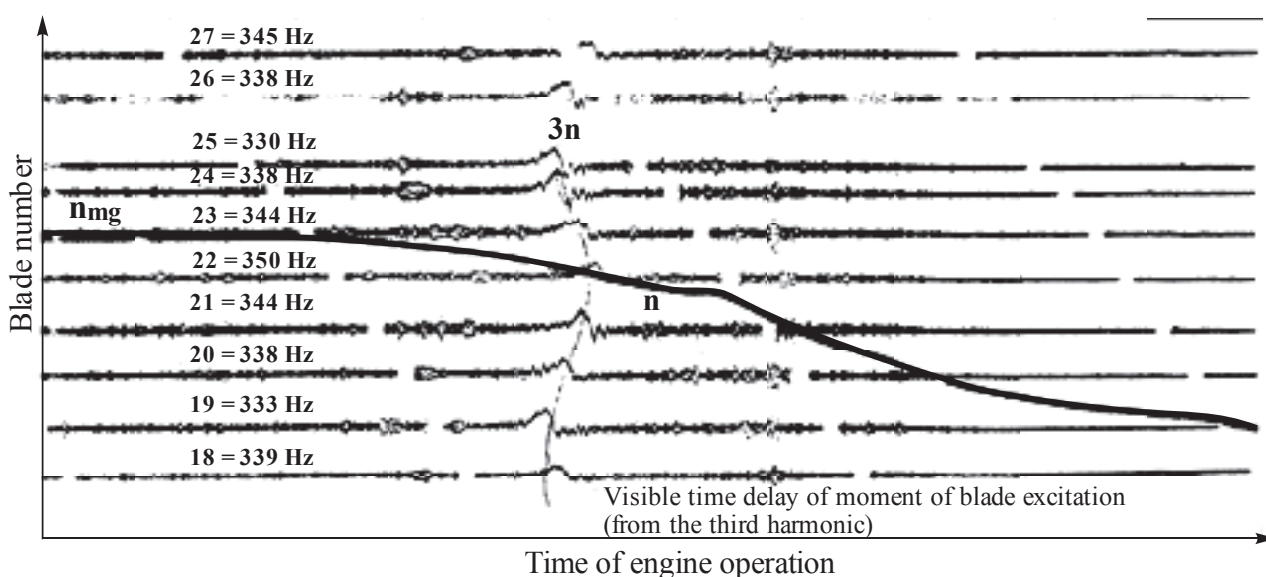
Fig. 8. Rotor blade vibration amplitudes. Visible excitations of blade vibration due to flow disruption by a sheet of paper lying flat on the guide vanes

Air flow through the engine inlet was disrupted by placing a piece of paper in the guide vanes of the compressor's 1<sup>st</sup> stage. The engine was started and its rotation speed was smoothly increased from  $n = n_{mg}$  to  $n = n_{max}$ . Blade vibrations were registered on a K12 oscilloscope (0). It turned out that at  $n = 8,000$  rpm vibrations are forced by 3EO with a considerable amplitude. Subsequently, strong resonance vibrations (from the 3EO) occurred at  $n = 14,800$  rpm.

Analysing the first resonance vibrations (from 3EO) one can clearly see that with the increase of rpm, the blades' resonance amplitudes form a sinusoid (0). This effect is used in a tip-timing analysis of blade vibration amplitudes to determine, on the basis of engine rotation speed, the vibration frequencies of synchronous blades. Knowing the exact rotation speed (excitation frequency), one can determine the free vibration frequency of blades subjected to mass force and working fluid flow.

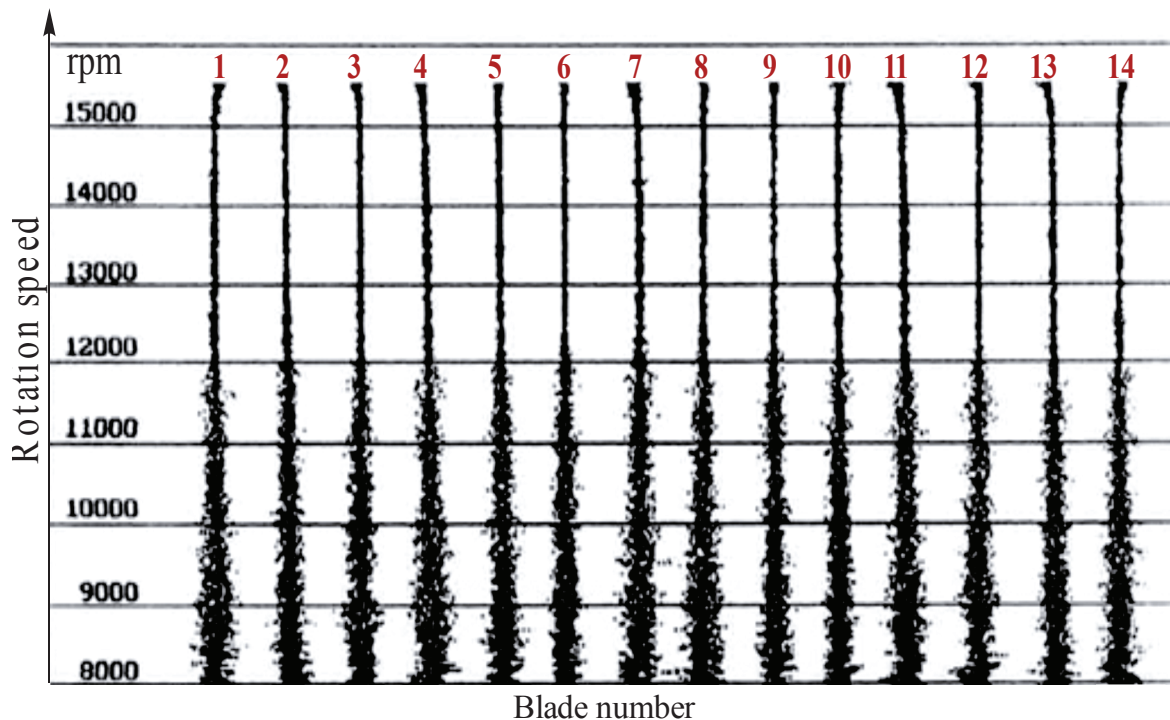
Fig. 9. Vibration amplitudes of rotor blades in the 1st compressor stage. Standard spectrum of one-pass engine compressor 1st stage rotor blades in aeroplane inlet

Figure 90 presents the vibration amplitude standard spectrum of 14 1<sup>st</sup> stage compressor rotor blades in an aeroplane inlet. The rotation speed, from 8,000 rpm to 15,000 rpm, is on the ordinate axis, and the blade numbers are on the abscissa axis. Asynchronous vibrations prevail up to  $n=12,000$  rpm. Above 12,000 rpm synchronous vibrations dominate and blade vibration amplitudes substantially diminish. Fig. 100 shows the vibration amplitude spectrum of compressor 1<sup>st</sup> stage rotor blades where one blade (nr 10) stands out on account of its deformed shape or faulty attachment to the disc. When the rotation speed is changed, this rotor blade bends differently in relation to the other blades (see incline between blades 10 and 11 in Fig. 100).

In the case of a foreign object, other flow asymmetry or rotor disruption the blades will have greater vibration amplitudes (Fig. 12), made apparent in vibrations excited by the second synchronous rotation speed (2n) at  $n = 14,800$  to  $15,500$  rpm. This effect is not observed for other rotor blades depicted in Fig. 9 at  $n = 14,800-15,200$  rpm.

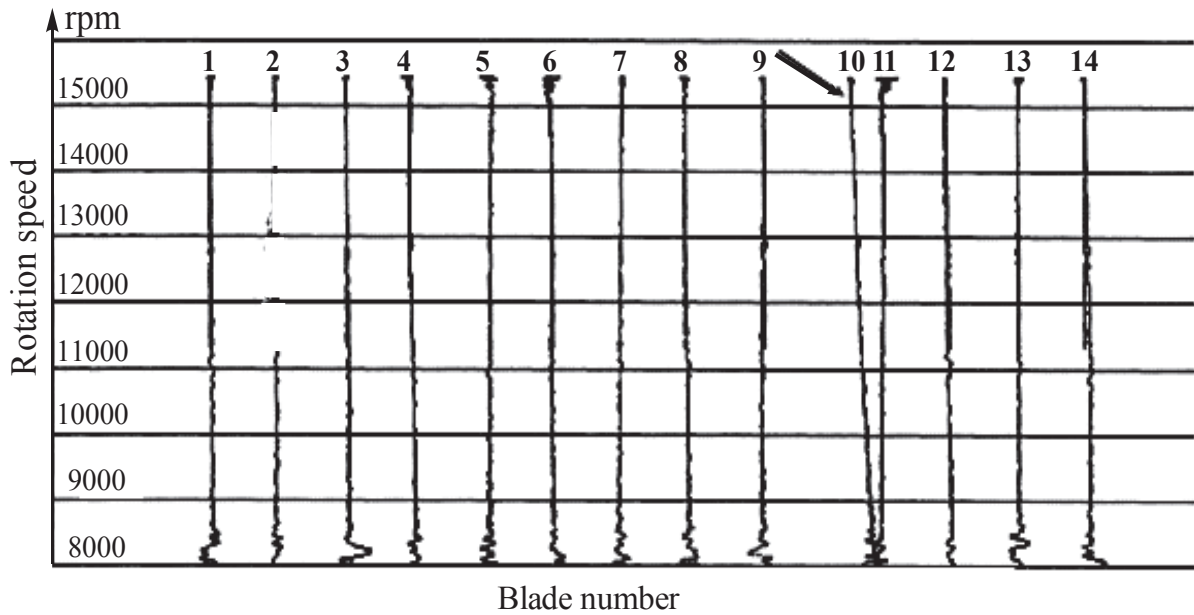
Fig. 10. Vibration amplitudes from 1<sup>st</sup> compressor stage rotor blades, with one rotor blade excessively deformed

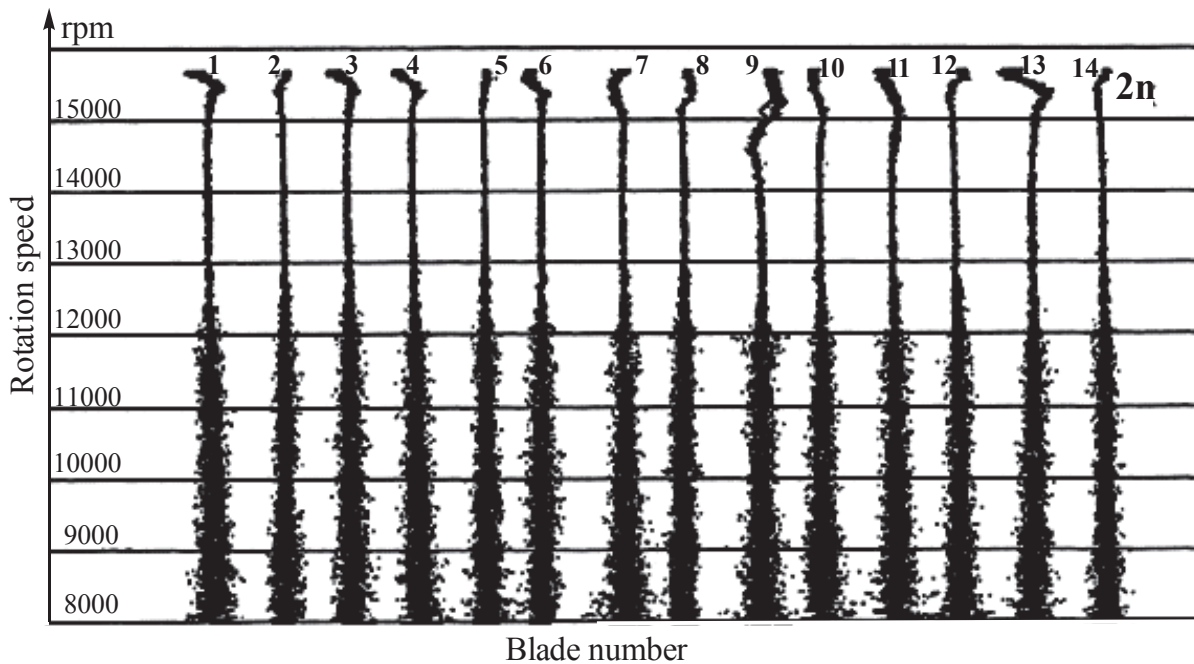
Fig. 11. Vibration amplitudes of one-pass engine compressor 1<sup>st</sup> stage rotor blades, with tendency to be excited by the second harmonic

The blade amplitude curves in time (vertical lines in Fig. 110) indicate a tendency for blades to excite 2EO (2n) vibrations, visible at  $n = 14,800-15,200$  rpm. This is due to the selection of rotor blades on the compressor disc whose vibration frequencies are from 490 to 500 Hz at 14,800 to 15,200 rpm.

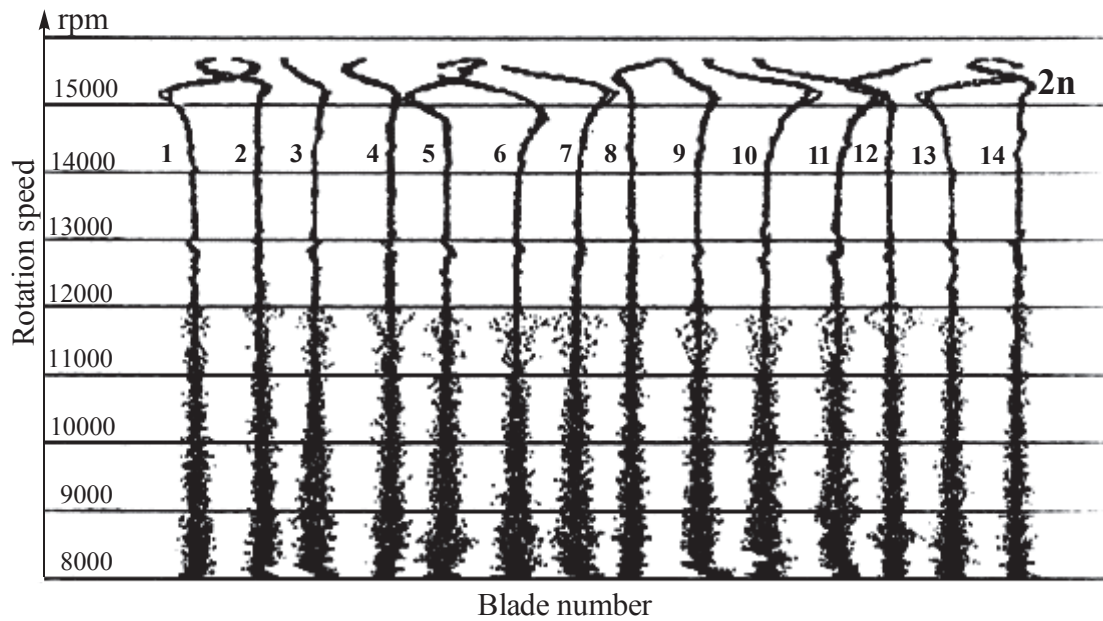
Fig. 12. Vibration amplitudes of compressor 1st stage rotor blades, with small foreign object on guide vanes

Figure 12 also shows increased blade vibration amplitudes at 11,000 to 12,000 rpm, indicating susceptibility to surges.

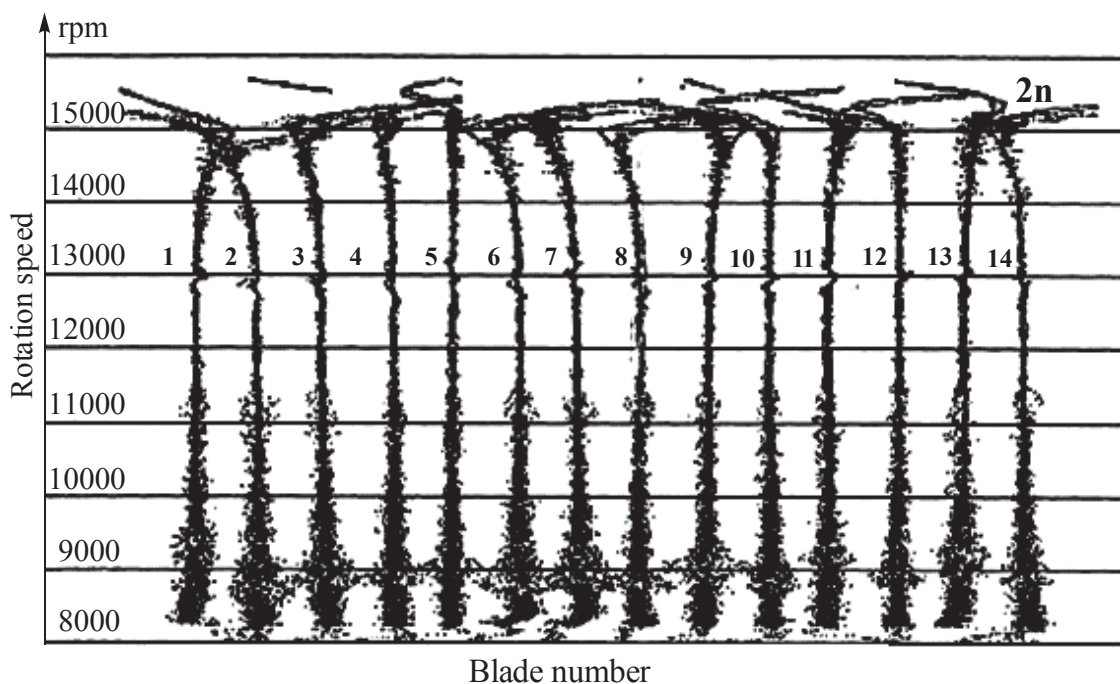
Fig. 13. Vibration amplitudes of compressor 1st stage rotor blades, with surge caused by a large foreign object on the guide vanes

Figure 13, in turn, presents blade vibration amplitudes during a surge caused by a large foreign object on the rotor blades. It occurs at above 14,900 rpm and the blade vibration amplitudes are much higher than in the case of 2EO (2n) as shown in Fig. 12. Fig. 13 also shows large blade vibration amplitudes excited by the 3EO at 8,000 to 9,000 rpm.

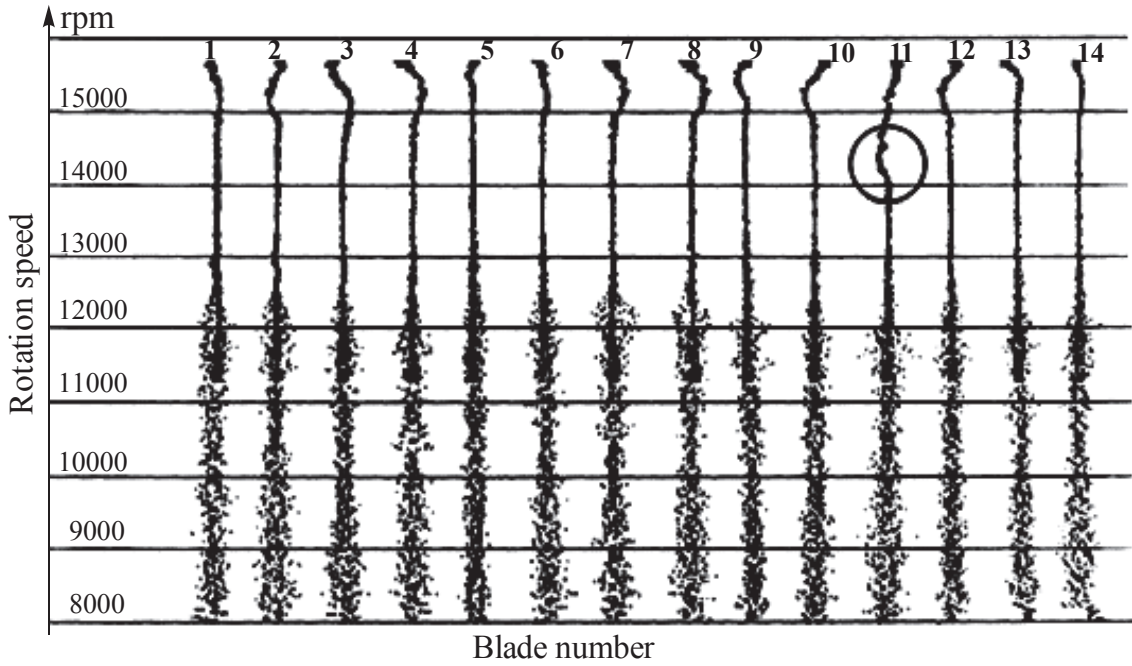
Fig. 14. Vibration amplitudes of compressor 1st stage rotor blades, with crack initiation in one of the rotor blades

Figure 14 shows the course of rotor blade displacement with one blade cracked (marked with red circle). The initial cracking phase may be indicated by a reduction in the blade's vibration frequency or the appearance of resonance generated by 2EO at 14,300-15,000 rpm.

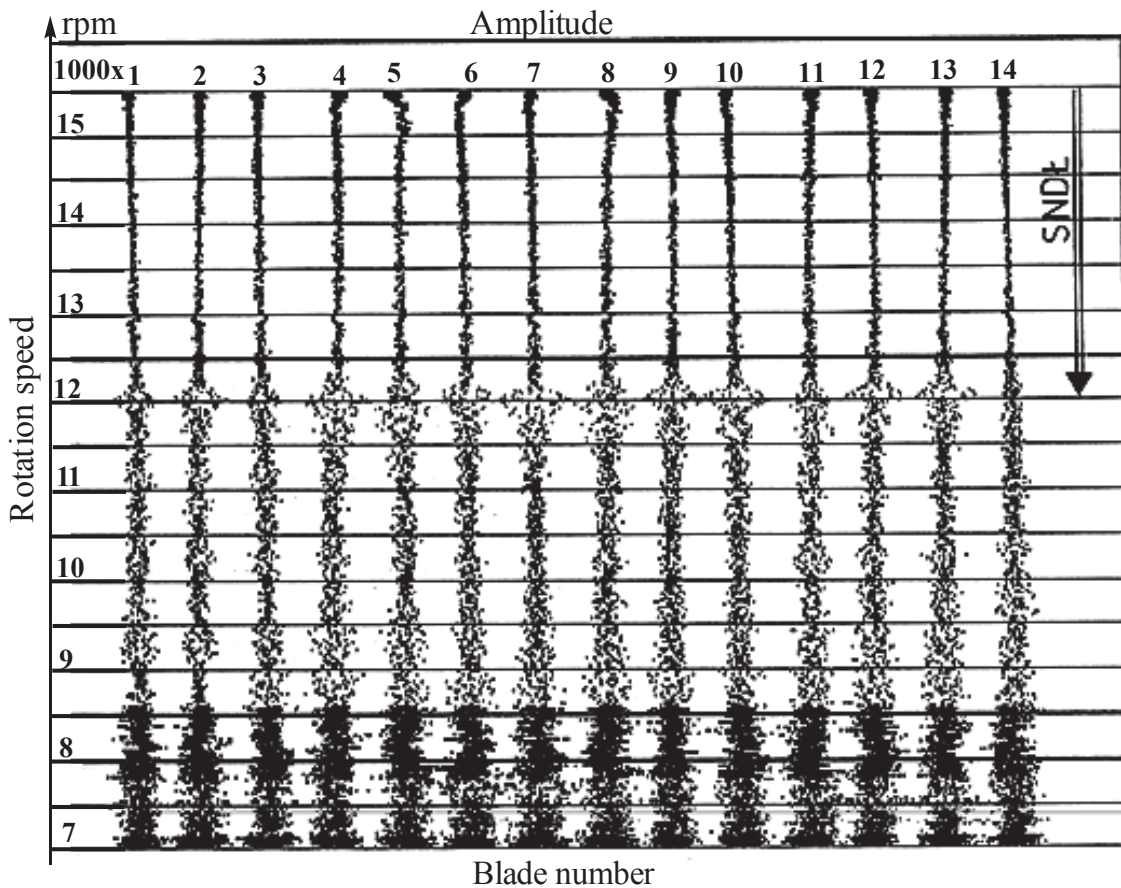
Fig. 15. Vibration amplitudes of compressor 1st stage rotor blades 1 and 14

The SNDL-1b and SPL-2b devices [2] make it possible to record increased blade stress amplitudes in working engines during aircraft flights. For instance, during one-pass engine trials [6] the compressor 1<sup>st</sup> stage rotor blade vibration amplitudes were additionally monitored by the SNDL-1b excessive vibration warning device. This test revealed (Fig. 15 and 16) that blade vibration amplitudes were larger at  $n = 7,000-8,000$  rpm than at  $n = 11,000-13,000$  rpm. It also showed that rotating stall zones disappear when rotation speed is increased to  $n = 13,200$  rpm. During repeated accelerations greater stress amplitudes appear at  $n = 12,000-12,500$  rpm than at 11,000 rpm. Two blades, marked in Fig. 16 with arrows, demonstrate different rigidity or mass distribution from the rest.

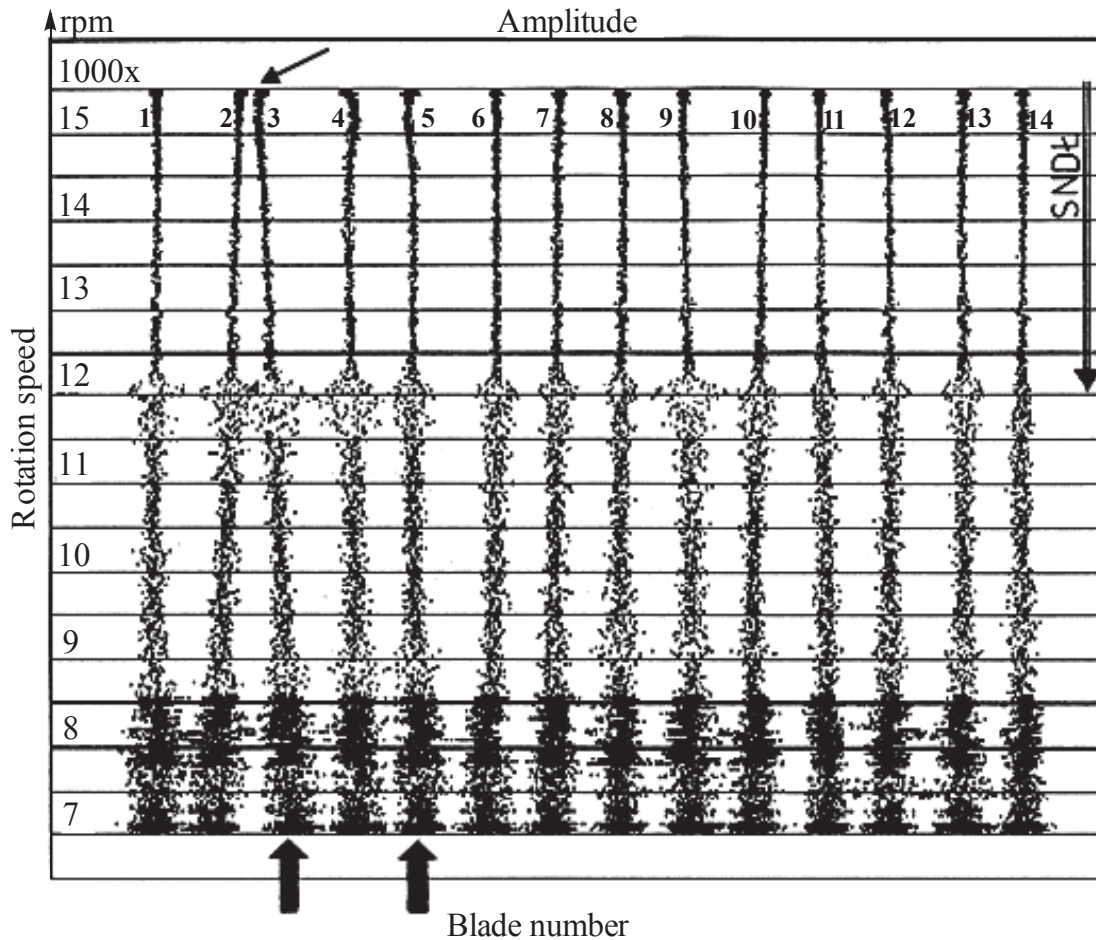
Fig. 16. Vibration amplitudes of compressor 1st stage rotor blades 15 to 28

The engine showed a permanent tendency of reducing the compressor safety margin and premature metal fatigue in its 1<sup>st</sup> stage blades caused by:

- impact of 3EO at about 8,000 rpm,

- impact of asynchronous rotating stall zones at 10,000 to 12,000 rpm,
- extensive vibrations that periodically appear at 12,000-12,500 rpm.
