SYMPTOMS DAMAGE TO THE HYDRAULIC REGULATOR PROPELLER LUN-7816

Abstract

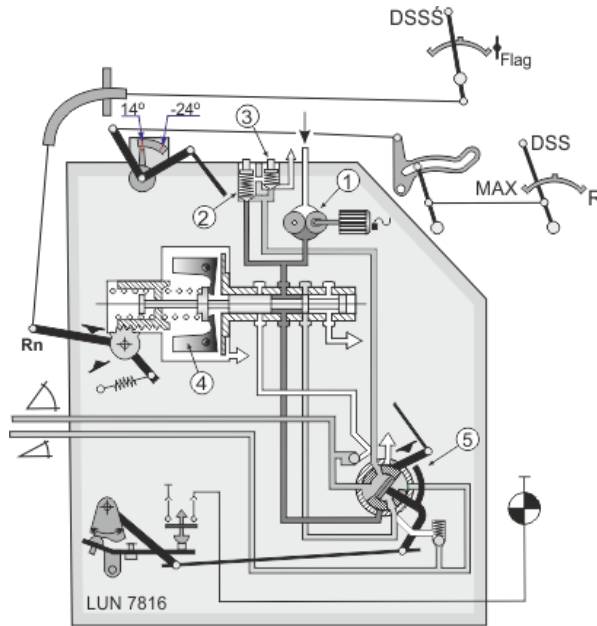
Fig. 1. Diagram of the LUN-7816 airscrew drive

The recorded moments of rpm and torque exceeding presented a set of factors that caused typical failures of the driving unit. Particularly dangerous were defects of the LUN-7816 hydraulic drive for the airscrew (Fig. 1) since these defects have led to several failures and a few dozen of hazardous situations that could possibly lead to an air accident.

The airscrew drive (Fig. 1) comprises a gear pump (1), pressure reduction valve RV-1 (2) for the maximum oil pressure, pressure reduction valve RV-2 (3) for the minimum oil pressure, centrifugal governor (4) and a reverse flow valve (5) – a set of bushings.

The analysis of the damaged drives demonstrated that the component that is most vulnerable to failures is the needle bearing HK1015 of the driven gear of the gear pump (1).

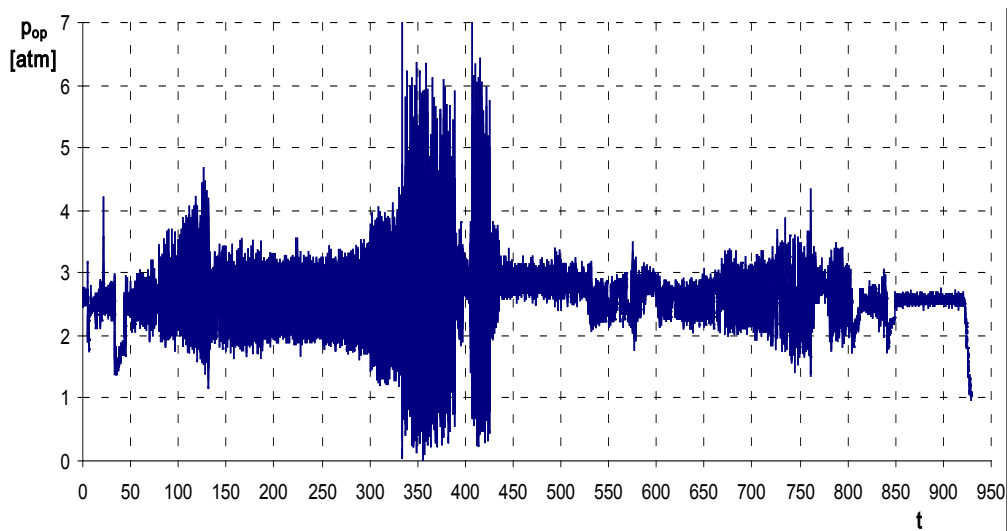
Fig. 8. Variation of oil pressure measured across the inlet to the gear pump of the LUN 7816 airscrew drive during a ground test of the aircraft #012 with the engine # 994002

The completed on-ground measurements of pressure values provided a profuse amount of data. The detailed analysis of that information makes it possible to assess technical condition of the airscrew drive and to find out the characteristic resonance frequencies. Fig. 7 presents profiles for the ground test of the aircraft engine, whilst Fig. 8, 9 presents waveforms for the measurements taken for the oil pressure.
