EXPEDIENT REPAIR OF HYDRO-PNEUMATIC PIPES WITH ADHESIVES

The paper presents research on expedient repairs, including battle damage repair methods of hydro-pneumatic pipes with adhesives. According to analyzed publications concerning battle damage of military equipment, various pipes and lines, which are used in military vehicles and aircrafts, are one of the most often damaged parts during combat operations. During experimental tests, the efficiency of damaged pipes repair was researched. Various methods of repair depending on pressure in the pipe and sort of damage were considerate. To conduct experimental tests of repair two kind of adhesive were used. It was composite adhesive Belzona 1111, which is used by many armies of NATO, and epoxy adhesive Epidian 57 hardened with Z-1. The conducted experiments proofed that both low pressure and even high pressure hydro-pneumatic pipes can be repaired in the field conditions with considered adhesives. Presented methods of repairs can be very useful especially during combat operations when the access to spare parts and disposal time is limited. Using to repair the manufacturer's composite adhesive without any strengthening should be limit

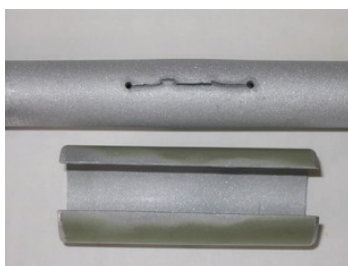
Preparing the damaged pipe to repair, the ends of cracks were drilled to prevent further propagation of crack. The surfaces of pipe near the damage and the interior surfaces of straps were prepared to repair by sandblasting and purified with petroleum ether (Fig. 5).

Fig. 5. The view of items prepared to bonding

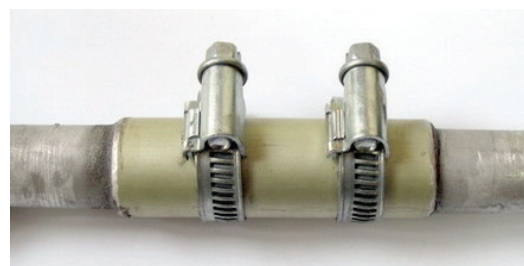
The straps length equal to 80 mm were based on recommendations given in the literature [8, 9], where is said that the repairs using adhesives composite should be carried out over a length of 20-30 mm from the edge of crack (crack length range from 26 to 29 mm). The same conditions of epoxy adhesives hardening were assumed, i.e. at temperature 60°C, hardening time – 1.5h. The pressures during bonding the straps were conducted using clamps (Fig. 6).

Fig. 6. The method of achieving pressure during bonding
